# COST-EFFECTIVE N/S SILL RESTORATION WITH EXPERT FABRICATION

## HIGH-QUALITY RESTORATION, BUDGET-FRIENDLY SOLUTIONS

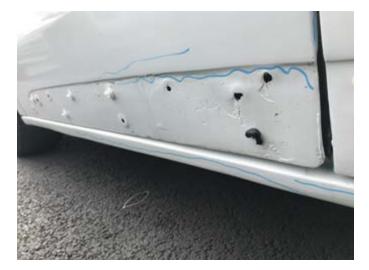
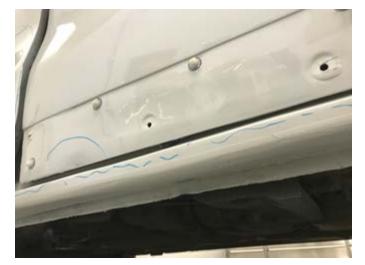
A customer approached us with multiple areas of damage to their vehicle, but they were particularly concerned about the N/S sill, which a previous service provider had poorly repaired. Upon closer inspection, we discovered full-length damage to the sill.

The previous repair involved filling extensive damage and holes, a temporary solution that didn't address the underlying issues.

We prioritise providing both high-quality and cost-effective solutions. After assessing the vehicle, our technicians removed the old filler and exposed the full extent of the damage to the original panel. While replacing the front door aperture and rear quarter panel would have been the typical route, we opted for a more economical approach without compromising on quality.

1. **Damage Evaluation:** After identifying the extensive damage to the sill, we decided to cut out the damaged section of the sill, which spanned the full length.

2. **Fabrication:** Using our in-house fabrication, equipment and skills, we crafted new sill panels that fit perfectly, replacing only the damaged section. This approach saved our customer significant off road time (hidden cost) and costs compared to replacing the entire panels.

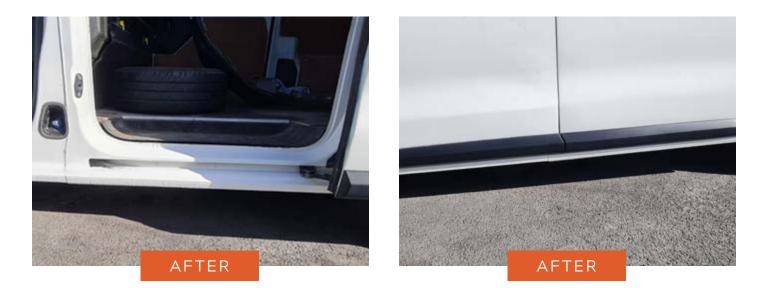
The damaged sill was carefully removed and replaced with new fabricated panels, restoring the vehicle at a much lower cost
