AMBULANCE ROOF PANEL REPLACEMENT, MULTI-POINT STRUCTURAL REPAIR AND FULL LIVERY RESTORATION

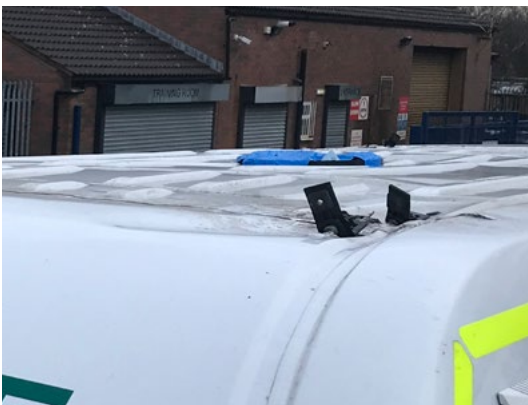
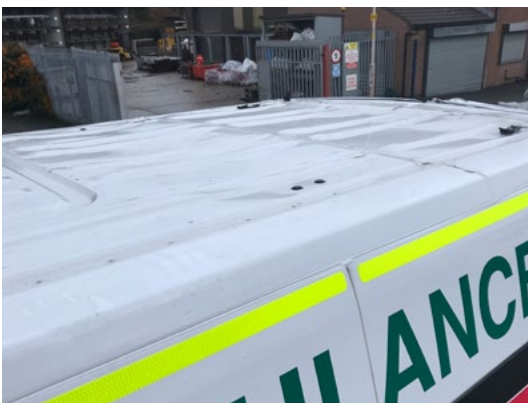
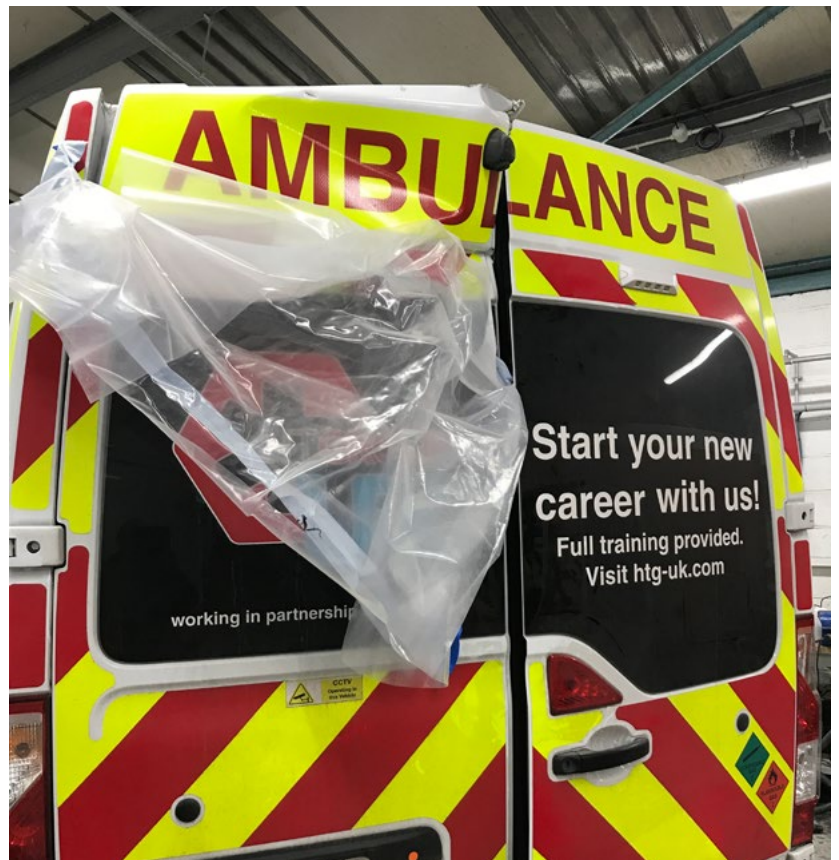
The impact stripped both blue light units and a number of other roof-mounted items clean from the vehicle. Damage ran the entire length of the roof, affecting both panels in full. The force of the collision had also caused both rear doors to pull away from the body of the van, and the cab cone had sustained damage as part of the same incident.

This was not a straightforward repair. It involved multiple interconnected elements across the bodywork, electrical systems, glazing, and livery - all of which needed to be resolved to return the vehicle to full operational specification.

The roof panels were fully replaced across the entire length of the vehicle. Throughout this process, close attention was paid to maintaining the integrity and quality of the bespoke internal passenger area - a significant consideration on an ambulance, where the interior specification is purpose-built and cannot simply be stripped back without care.

The damaged blue light units and associated roof-mounted equipment were removed, assessed, and replaced. This element of the repair went beyond a straightforward refit: the wiring system required full rewiring to restore correct functionality. All connections were documented and tested thoroughly before the vehicle was signed off.

Both rear doors, which had pulled away from the body of the van during the incident, were reinstated and realigned. Rear door windows were fitted as part of this element of the repair, restoring the vehicle to its original specification.

The damaged cab cone was repaired and returned to the correct condition and appearance.

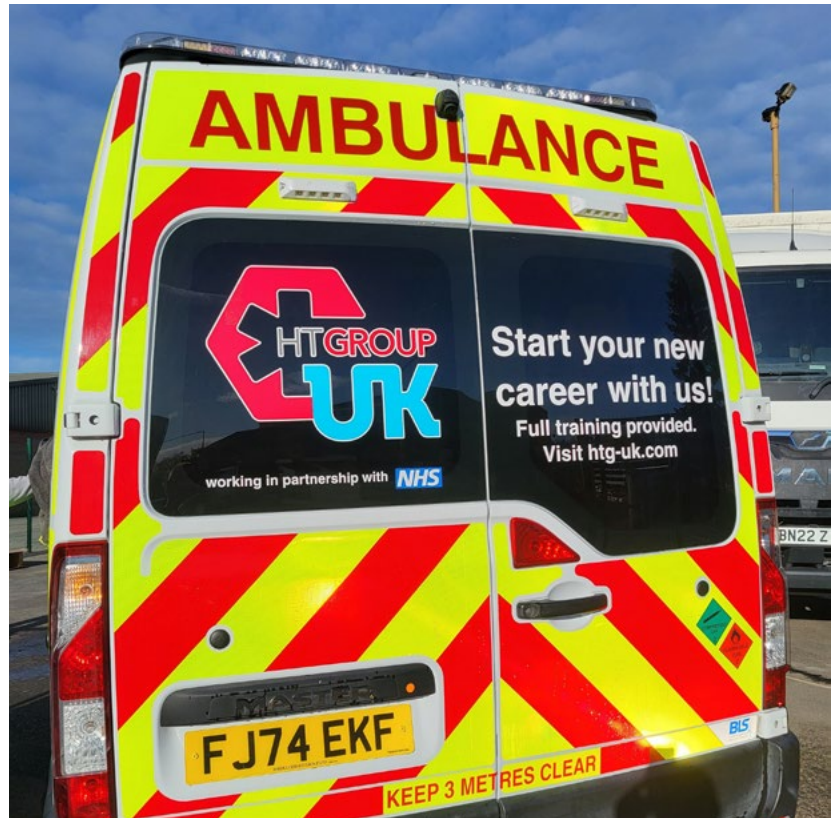
The ambulance was returned to its operator in full operational condition, structurally sound, with all blue light and emergency warning systems fully rewired and tested, rear doors correctly aligned and glazed, and livery reinstated to fleet standard.
