**Budget Mobile Bodyshop Ltd**

# TRUCK REPAIR FOR A **TEMPERATURE-CONTROLLED TRANSPORT SPECIALIST**

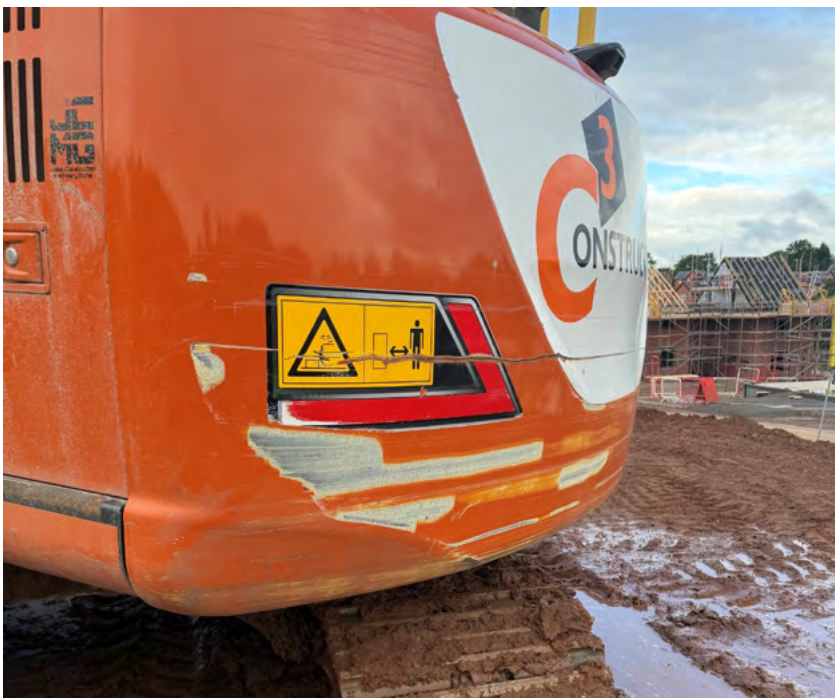
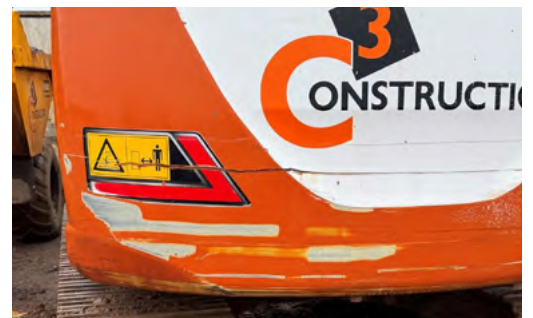
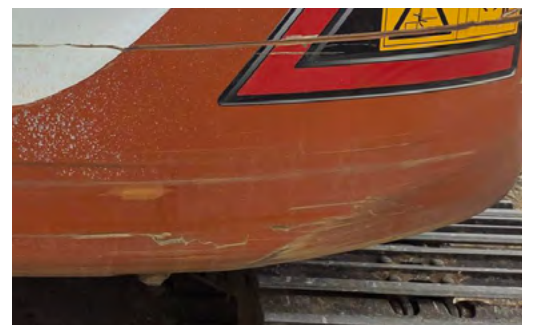
The rear counterweight had sustained a series of impact strikes and heavy abrasion. Deep scrapes and gouges ran across the panel, with several areas rubbed back to bare metal. Sections of the paintwork had cracked and lifted, and the surface finish had been compromised across a wide area.

**Surface Preparation** The damaged areas were stripped back and sanded to a clean substrate. Loose paint, cracked coatings and surface contamination were fully removed to give a sound base for the repair.

**Filler and Body Restoration** Deep gouges and impact marks were filled and flatted back to restore the original panel profile. This stage was worked over multiple applications to bring the surface to a true finish before priming.

**Primer and Paint** Once the substrate was fully prepared, primer was applied across all repaired sections. The counterweight was then colour matched to the existing Hitachi orange and sprayed to a full factory-standard finish, with the surrounding panels blended to avoid any visible transition.

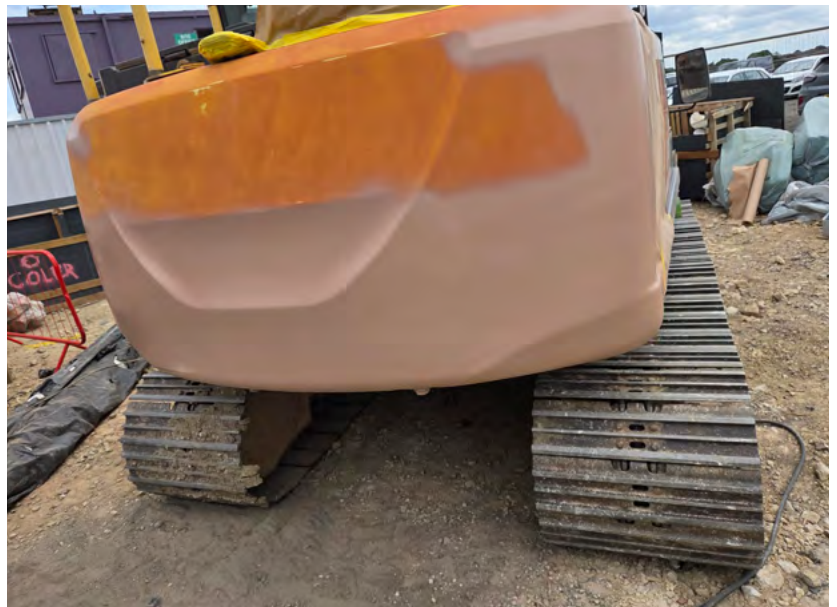
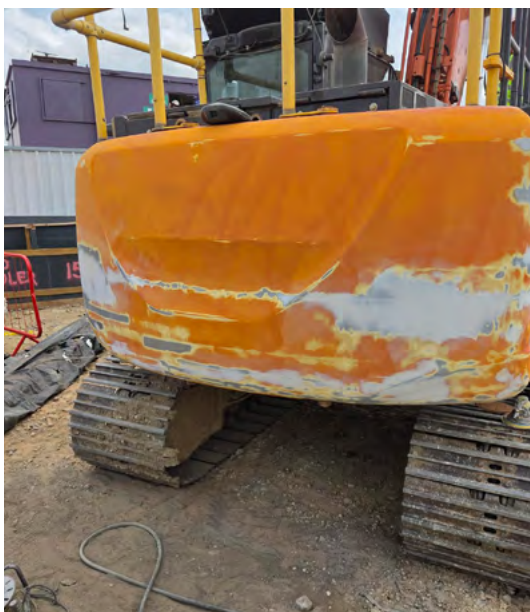
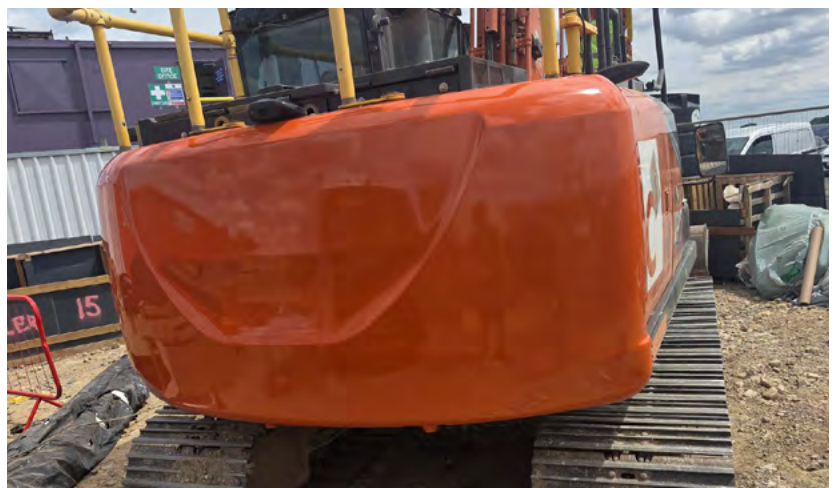
The excavator was handed back to C3 Construction in full working condition **with a factory-standard finish across the repaired area.**
